Influence of Jacking Oil Supply Configuration on Shaft Vibration of a Super-Synchronous Motor

Tim Hattenbach, P.E.
Feroze Meher-Homji, P.E.
Bechtel Corporation Houston, Texas

CASE STUDY: 38TH TURBOMACHINERY SYMPOSIUM

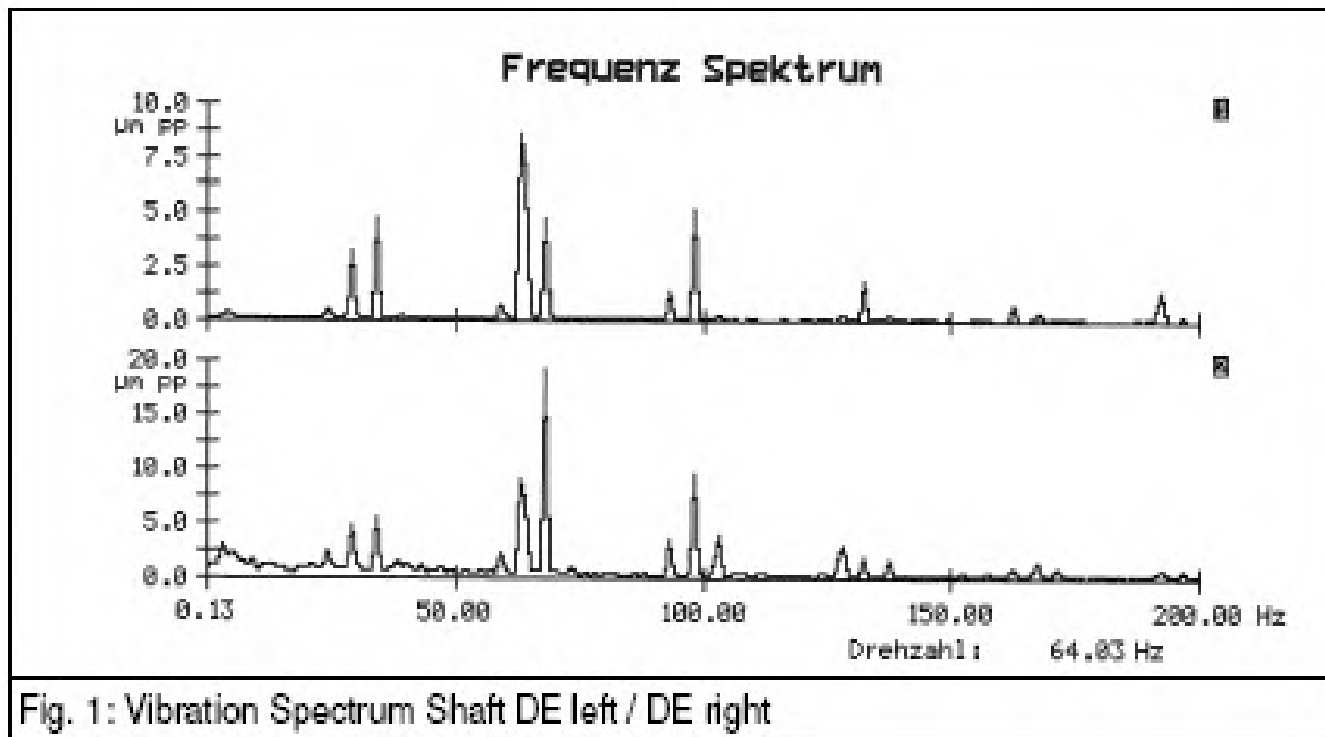
Fig. 1: Vibration Spectrum Shaft DE left / DE right

- OEM conducted a test at 4200 RPM (82 % of Running Speed). This was the test speed in the OEM's original scope.
- Motor exhibited fractional harmonics of running speed
- Problem attributed to inadequate labyrinth clearances

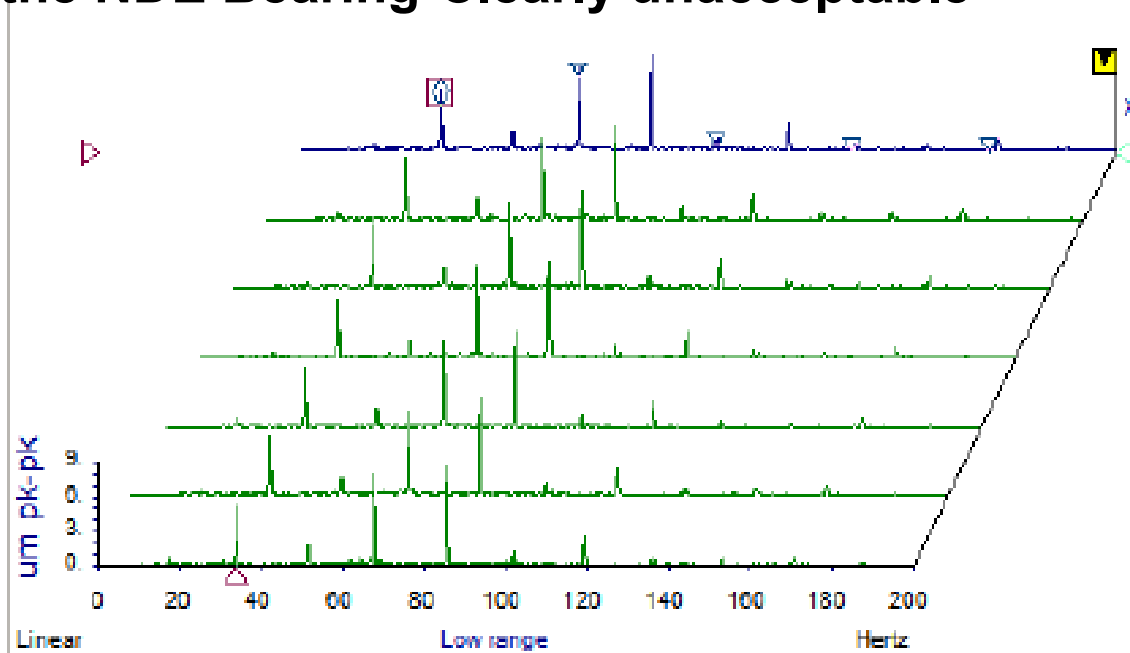
Fig. 4: Vibration Spectrum Bearing DE left during operation at 5110 rpm

Max vibration 51 microns pk-pk -SSV noted at 1st Bending Critical and its second harmonic

High sub-synchronous vibration above 4800 RPM-Because of the contractors's insistence the motor was run at its rated speed 5100 RPM .The unfiltered vibration exceeded 50 Microns Pk-PK at the NDE Bearing-Clearly unacceptable

Root cause attributed to low damping and oil whirl in the 4 lobe bearings

4 lobe Load between Pads Tilting pad bearings designed to replace existing bearings- design constrained by existing bearing housing.

A new lateral analysis with the proposed revised bearing design-4 pad tilt pad bearings- Showed significantly improved damping

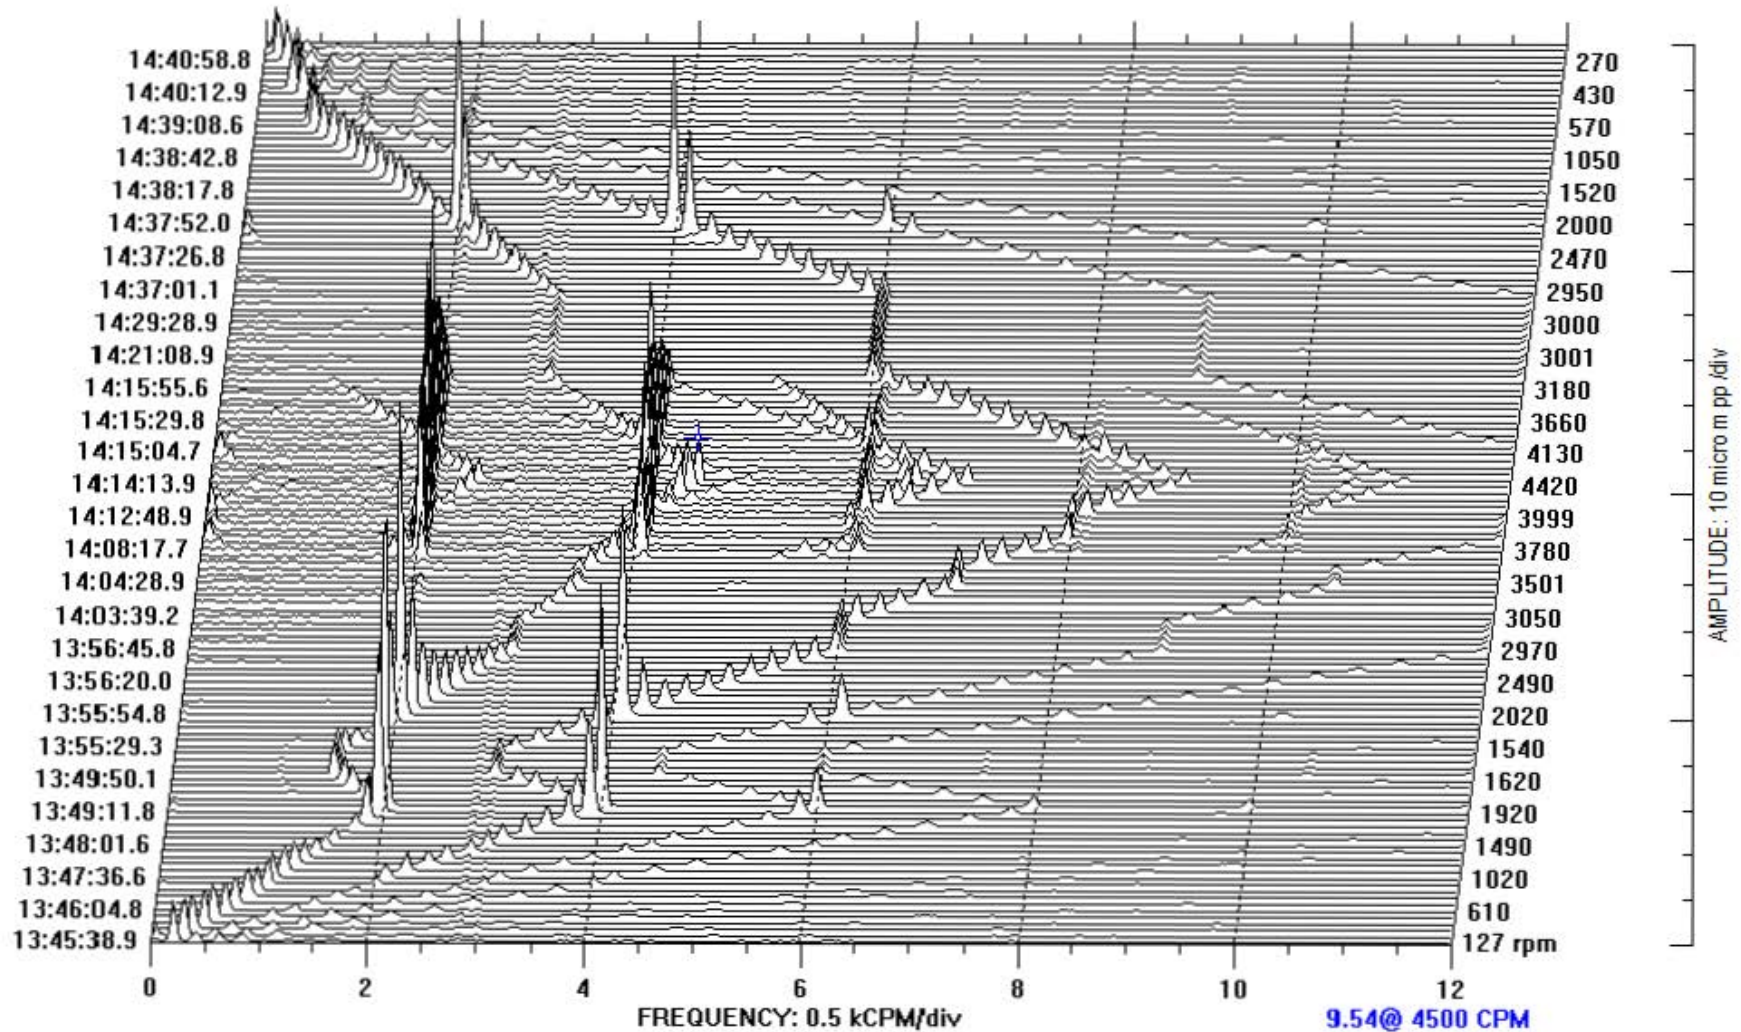
Witness Test with TPJs-Vibn too high to reach rated speed

POINT: SHR.NDE.RI /45° Right

MACHINE: Motor NDE

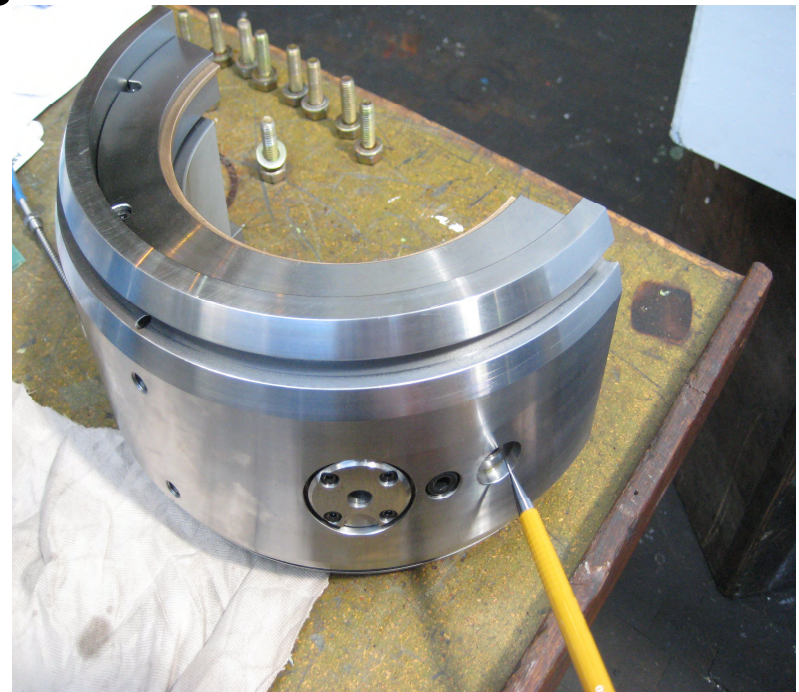
[A] Hole in Housing Left Open

**Hole for spare RTD left unplugged
allowing oil drain from housing**

**Slight improvement but SSV
persists.**

**Hole Plugged and Machine
retested.**

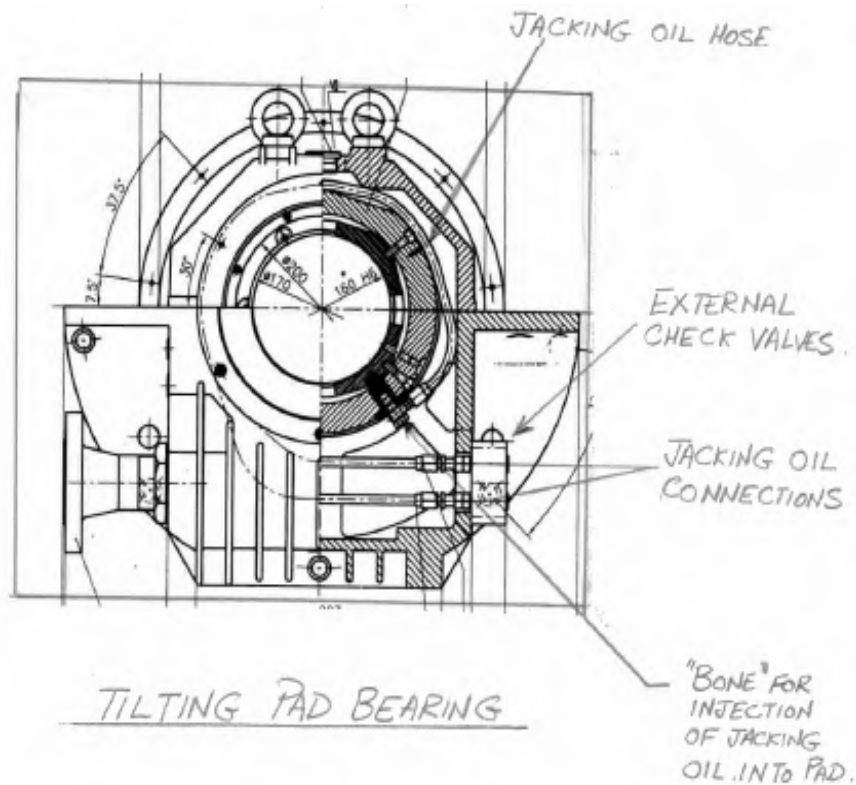
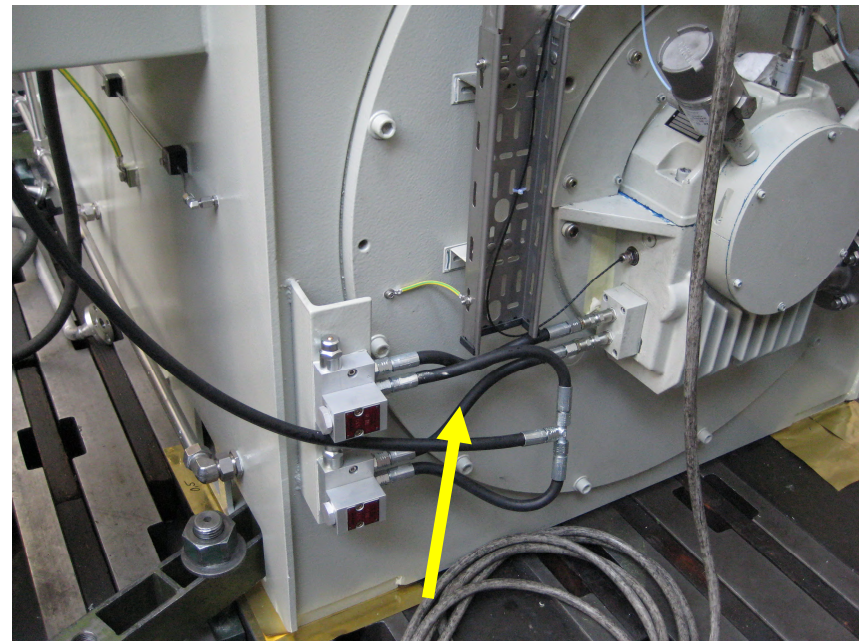
[B] Elimination of Jacking Oil

Trapped volume of oil /air between external check valve and port in pad deemed responsible for SSV

by disconnection of hoses and plugging of jacking oil ports in pads.

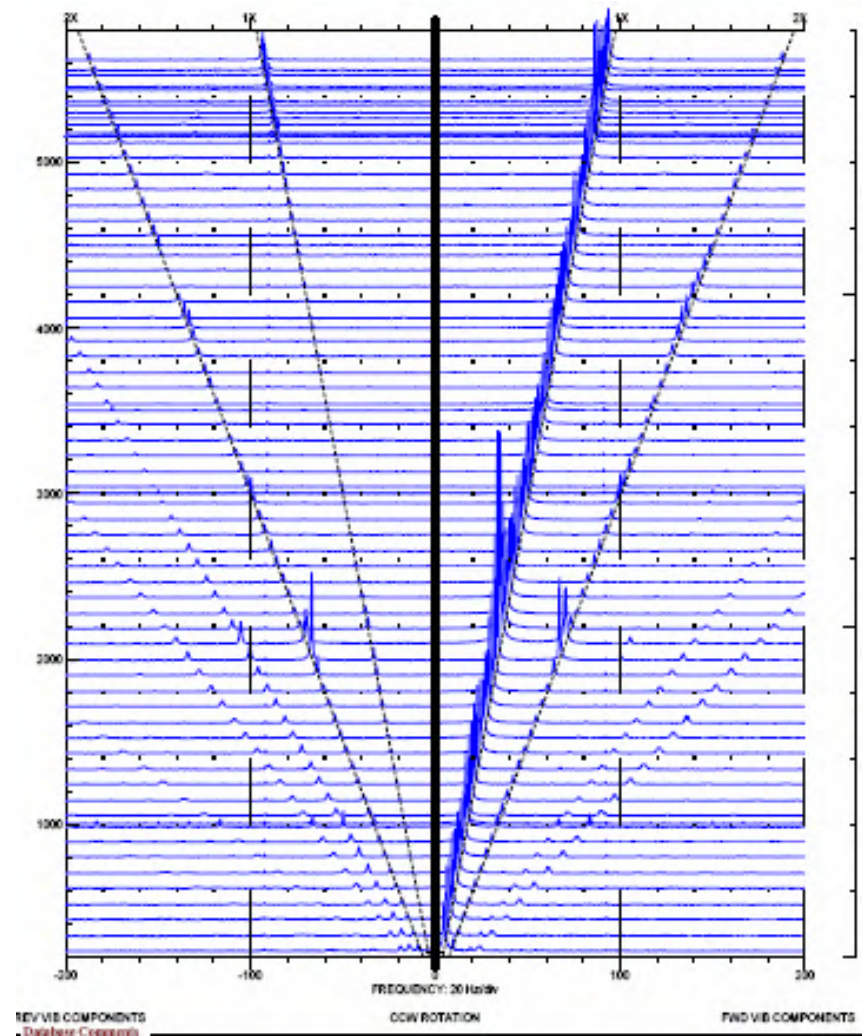
Tests indicated no SSV

Low vibration levels

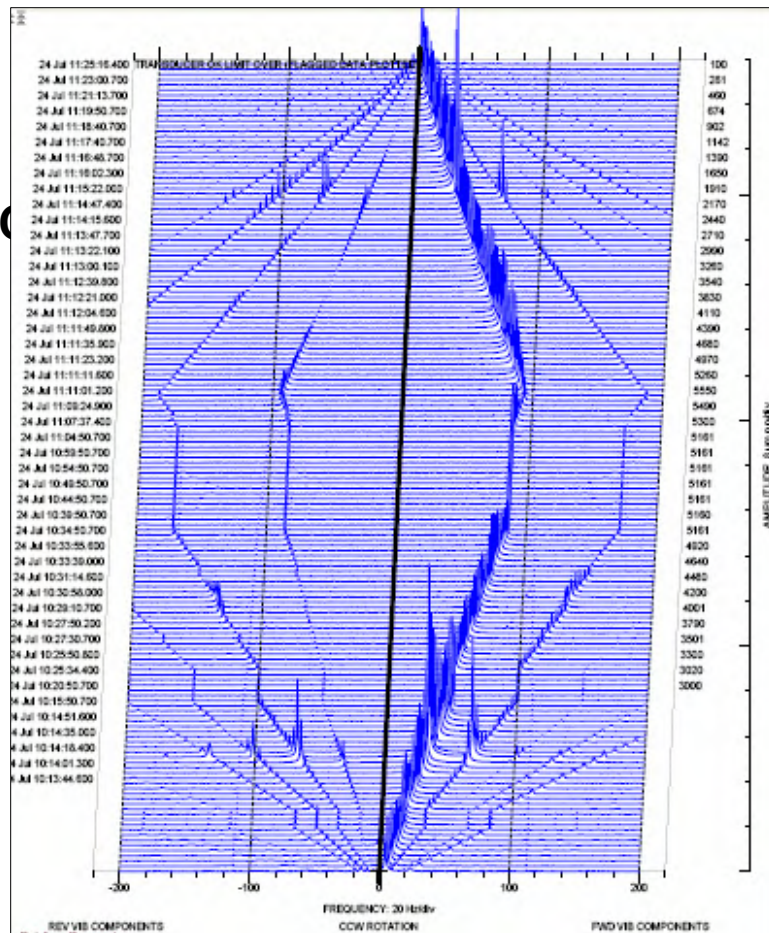
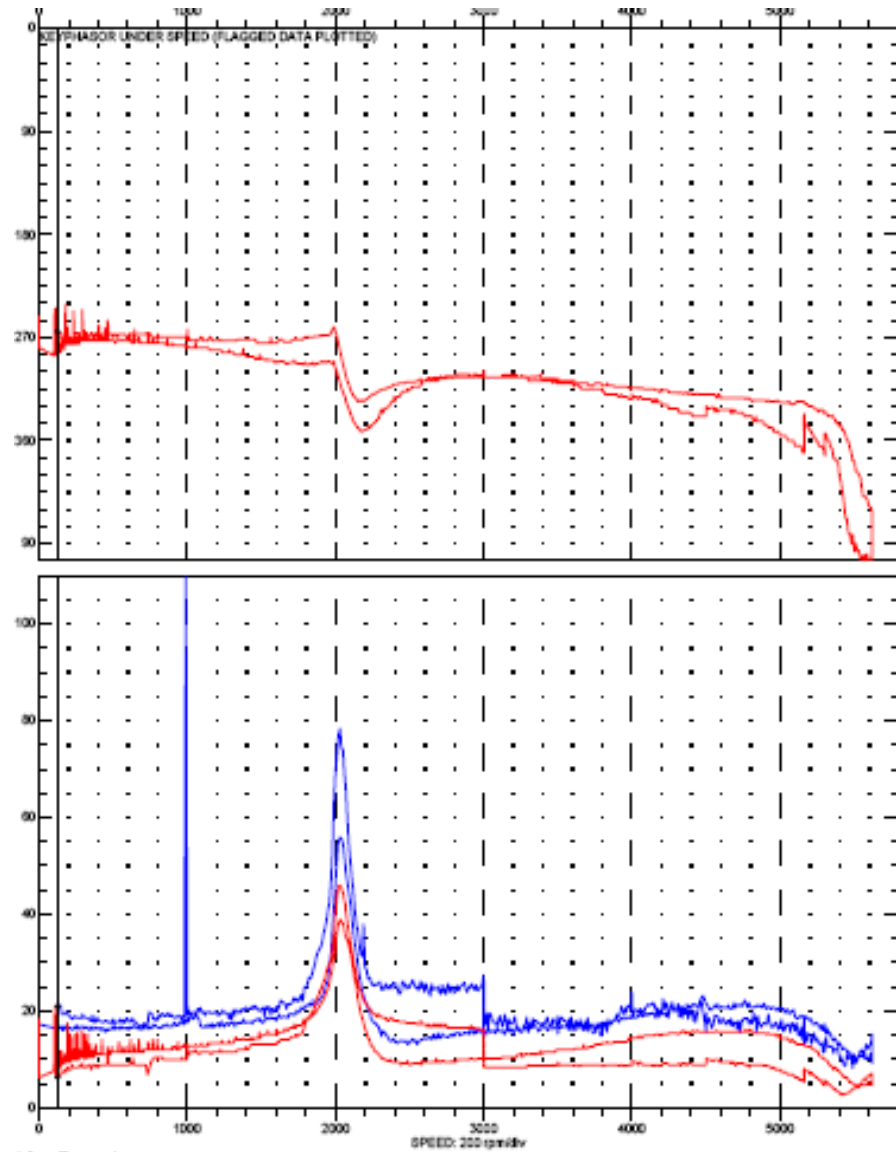
Final Test Showed good vibration levels 20 microns at overspeed and no SSV.

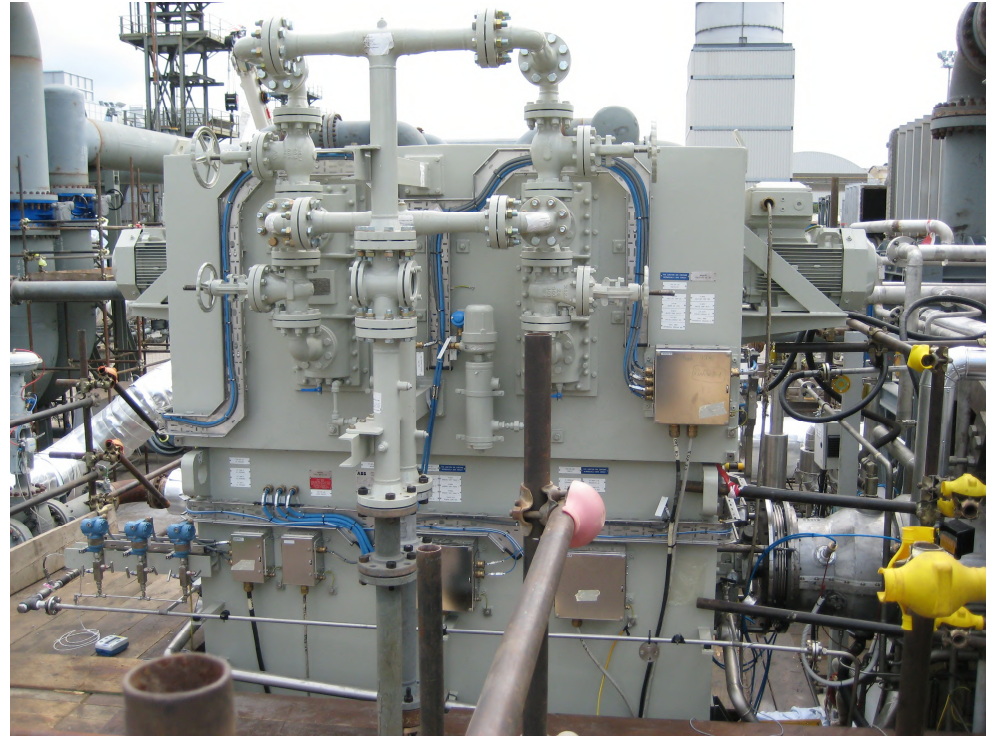
Motor Vibration Levels at String test ranged from 15 to 21 microns pk-pk

No SSV noted
